VERIFICATION REQUIREMENTS FOR COVER SYSTEMS

Technical Guidance for
Developers,
Landowners and
Consultants

**Yorkshire and Lincolnshire
Pollution Advisory Group**

Version 3.4 – November 2017

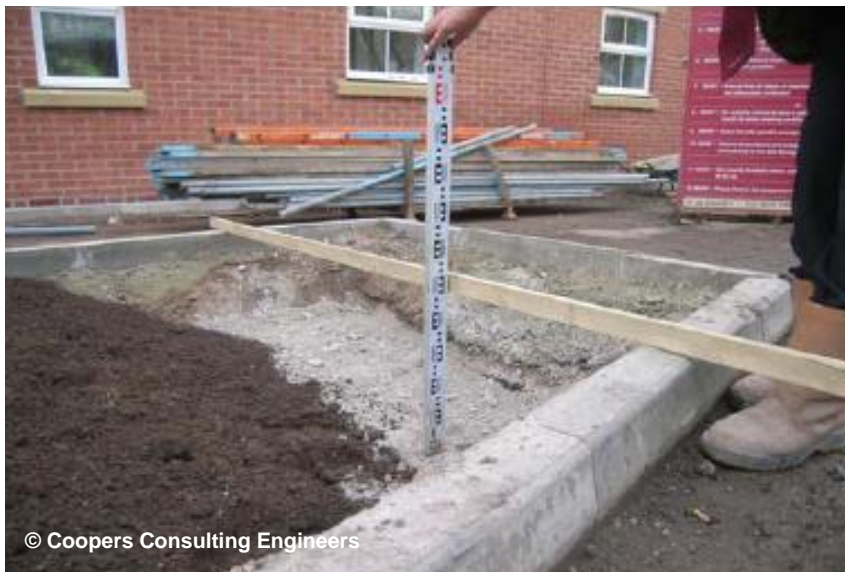
Photograph 1: Depth check of inert cover within area of public open space. Physical break layer and topsoil visible.

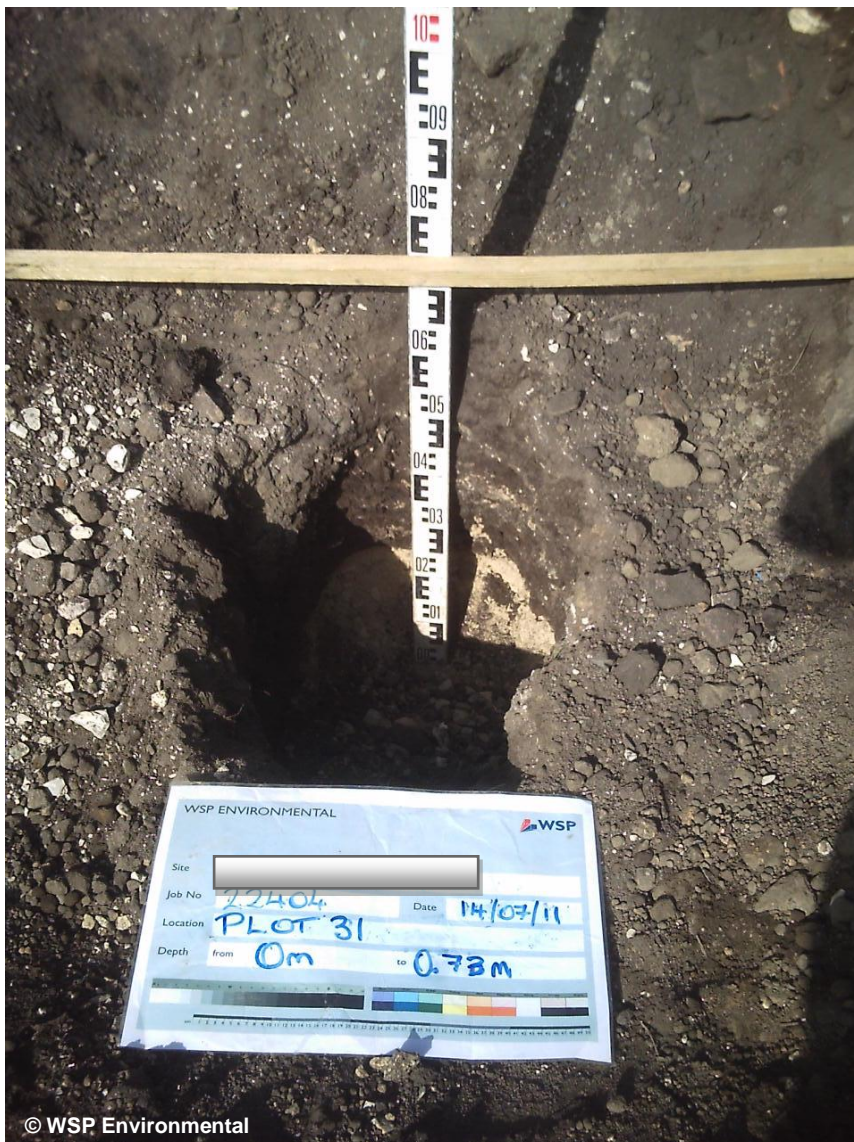
Photograph 2: Depth check of inert cover with Site & Location Information Board.

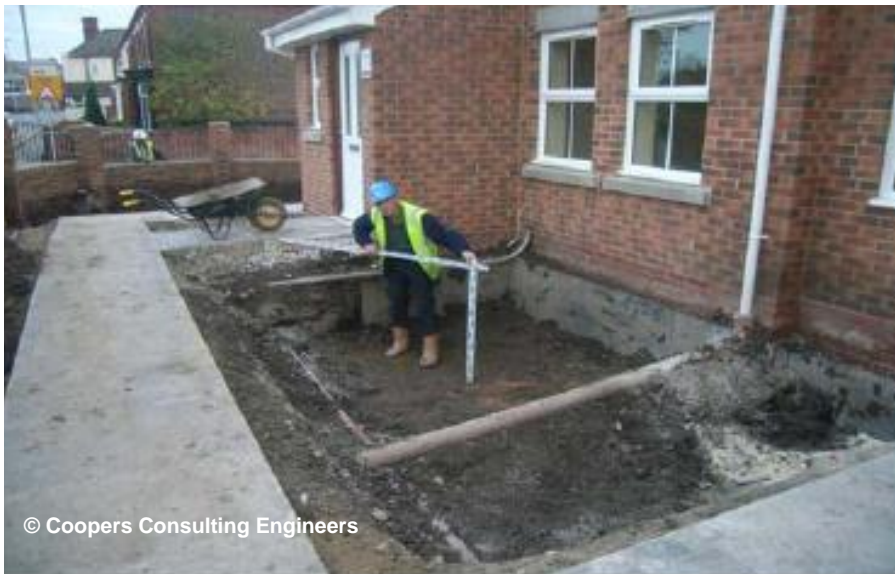
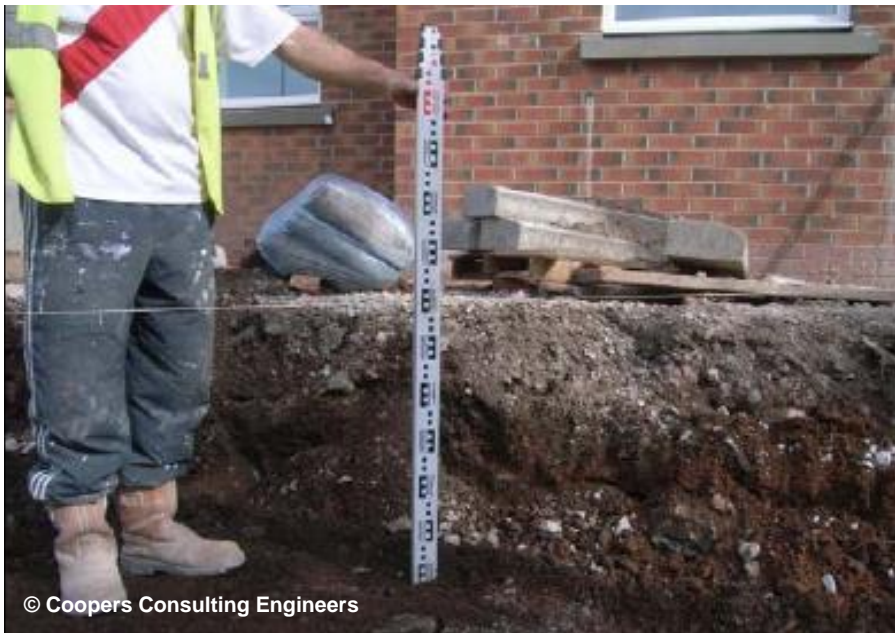
Photographs 3 & 4:
Depth check of inert
cover within areas of
front gardens.

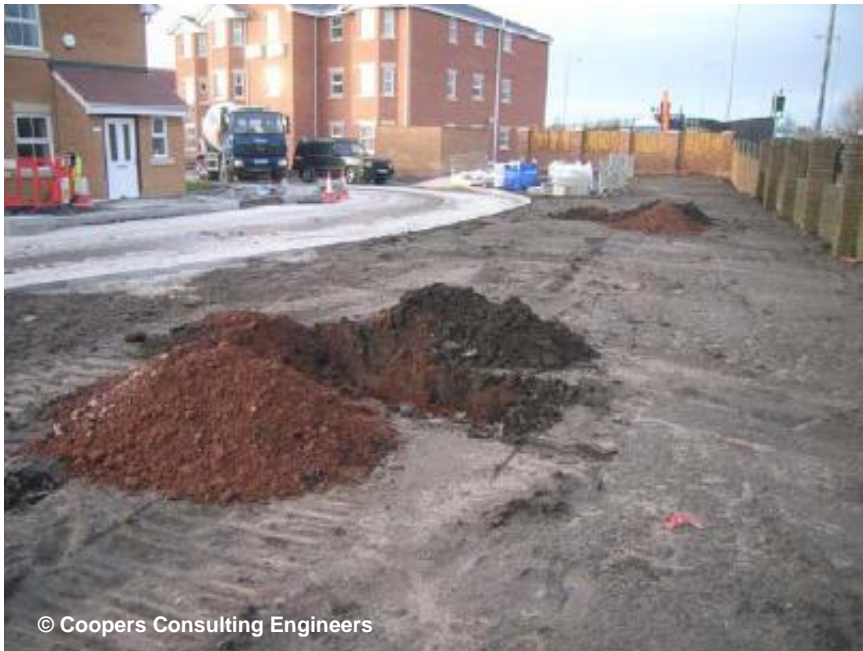
Photographs 5 and 6: Depth check of inert cover within rear gardens. Taut string line spans across excavation.

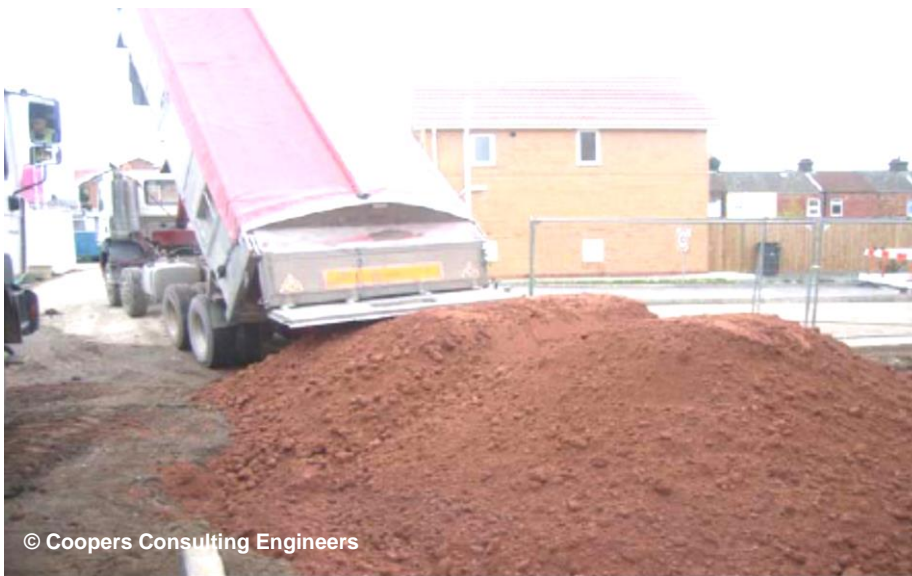
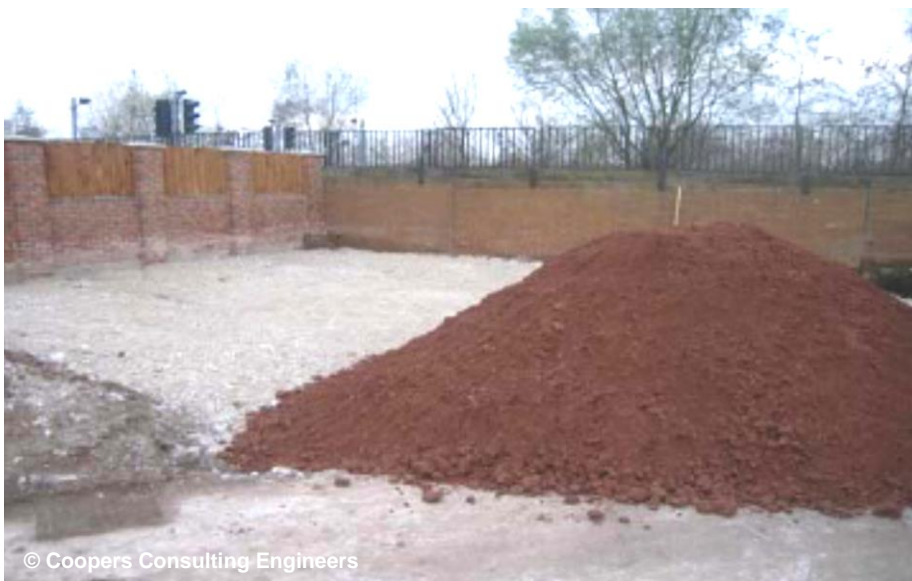
Photographs 9 and 10: Inert crushed sandstone being delivered with remediation break layer visible in Photograph 10. The spatial area of the remediation can be observed from these photographs (old terrace housing in Photograph 9 and traffic lights in photograph 10).

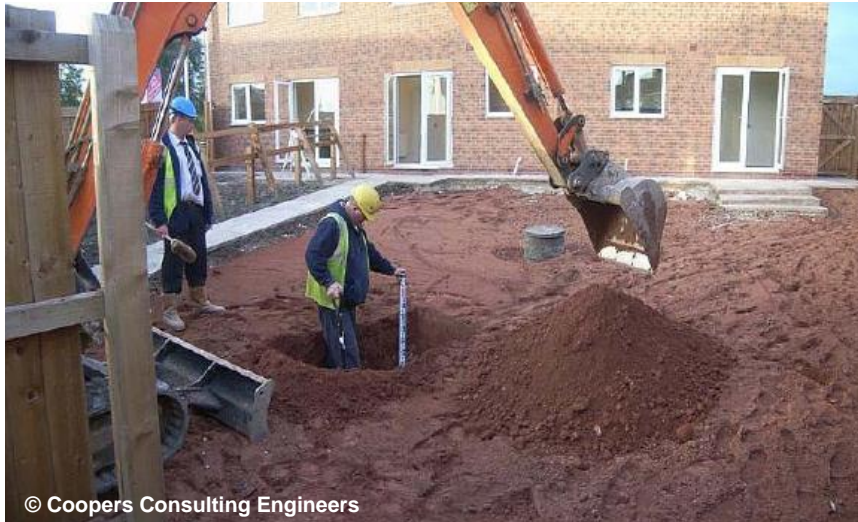
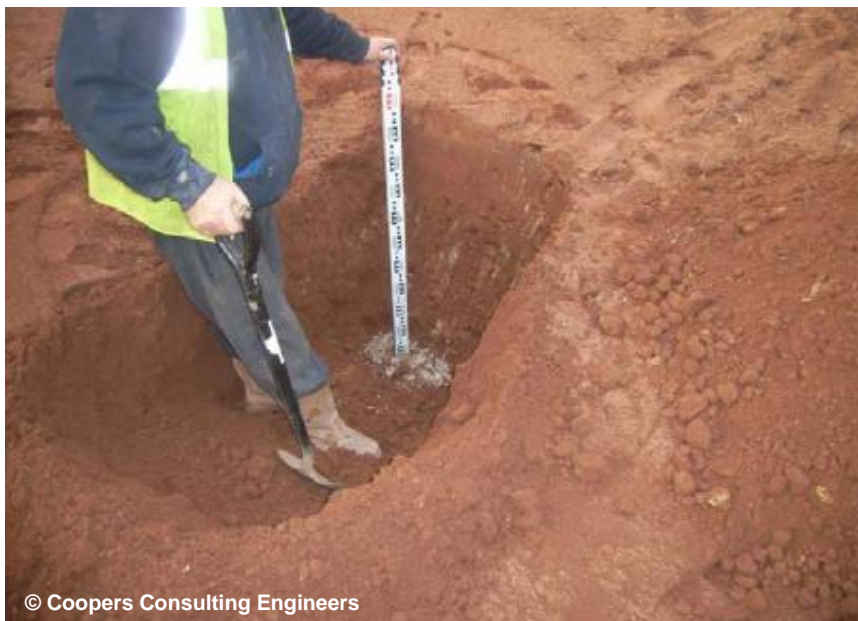
Photographs 11 and 12 show the remediation of the rear garden, with a significant depth (1.0m) of inert cover. Remediation break layer visible at the base of the excavation. Photograph 11 has been stitched to form a panoramic photograph and
