VERIFICATION REQUIREMENTS FOR GAS PROTECTION SYSTEMS

Technical Guidance for
Developers,
Landowners and
Consultants

Yorkshire and Lincolnshire
Pollution Advisory Group

Version 1.1 – December 2016

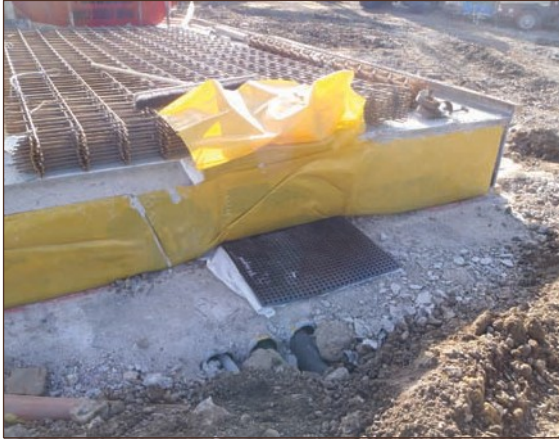
Figure A4.7 Geovent protruding out of the frontage of the unit. Gas membrane along the sides of the slab preventing lateral gas ingress (courtesy Alderburgh Group)

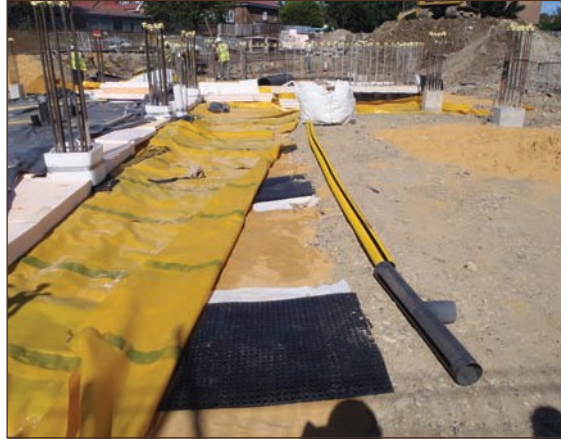
Figure A4.8 Geovent beneath the 2000g taped gas membrane lined up with collector pipes (courtesy Alderburgh Group)

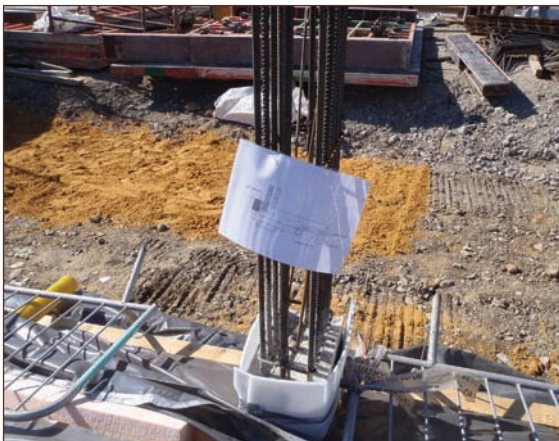
Figure A4.9 On site schematics to aid construction workers build the gas protection system (courtesy Alderburgh Group)

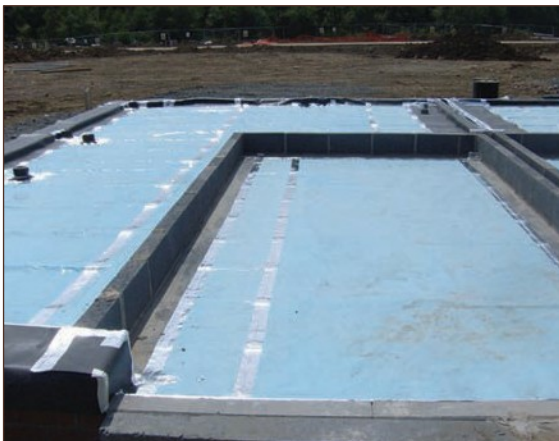
Figure A4.11 Gas membrane continued through cavity wall and above air bricks (courtesy Hydrock)

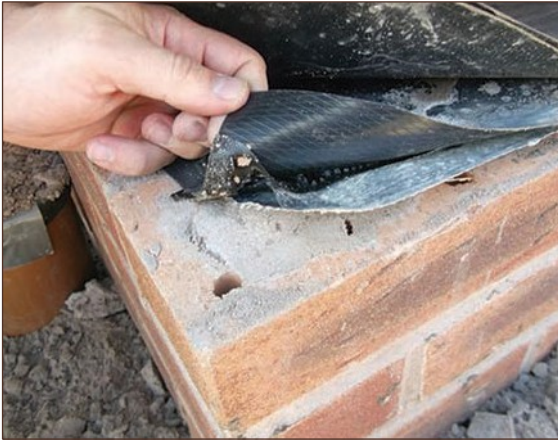
Figure A4.13 Gas proof DPC adhered on top of gas membrane using butyl strips across cavity space (courtesy NHBC)

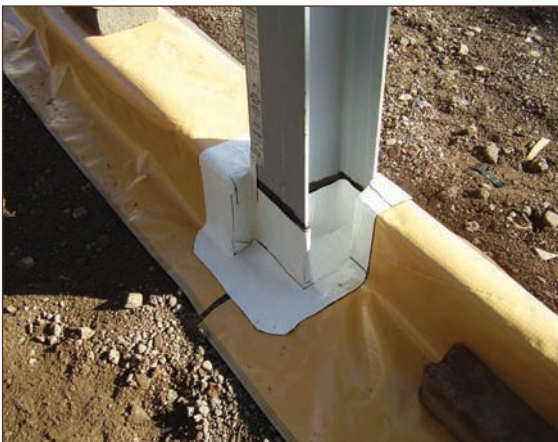
Figure A4.23 Complex column seal (courtesy PAgotechnical Ltd)

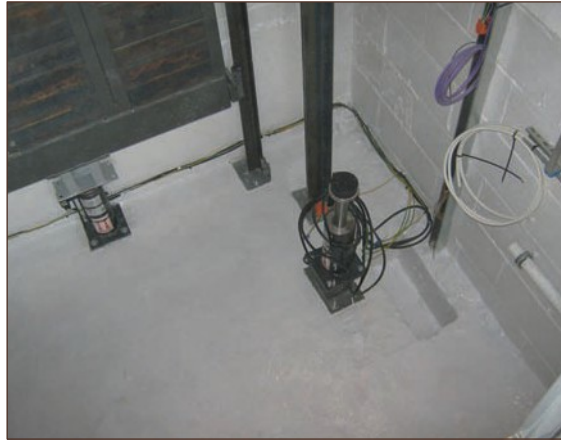
Figure A4.32 High quality installation of liquid gas membrane to lift pits, including resin gas protection on all screw penetrations (courtesy Card Geotechnics Limited)

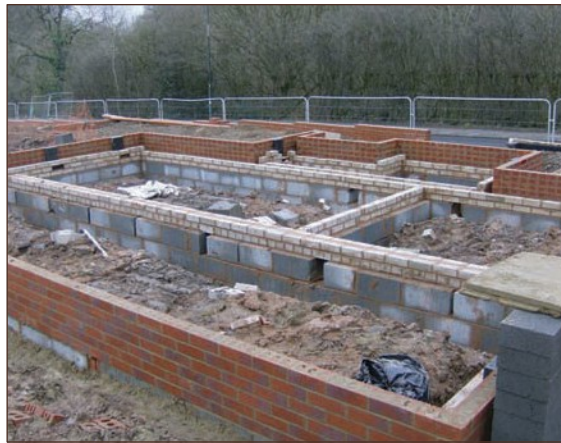
Figure A4.34 Open void >300mm deep, good ventilation through internal sleeper walls (courtesy Smith Grant)

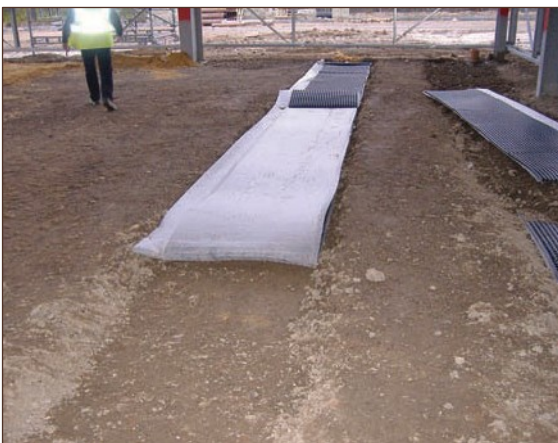
Figure A4.35 Good installation of passive gas venting trenches and 'egg-crate' (courtesy Card Geotechnics Limited)

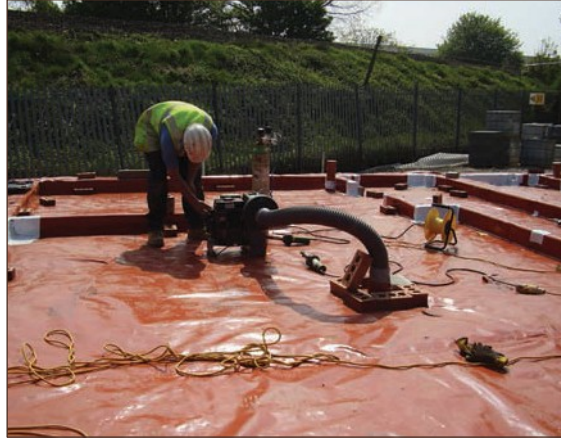
Figure A4.38 Tracer gas testing (courtesy PAGeotechnical Ltd)

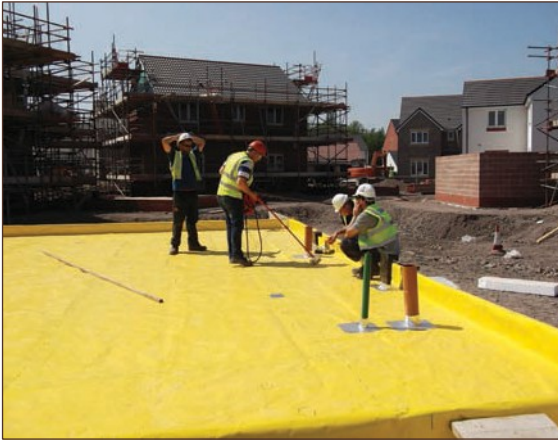
Figure A4.43 Dielectric porosity testing for housing scheme (courtesy NHBC)

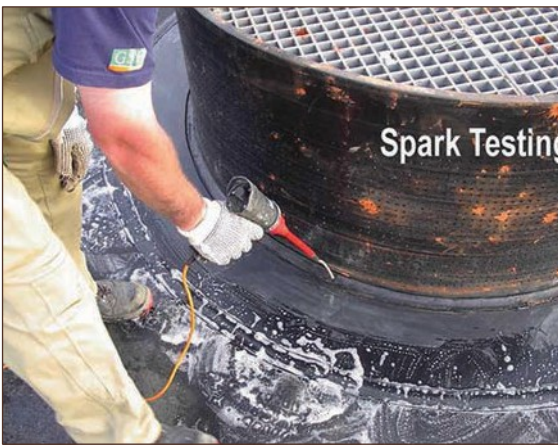
Figure A4.45 Spark testing (courtesy GSE Environmental)

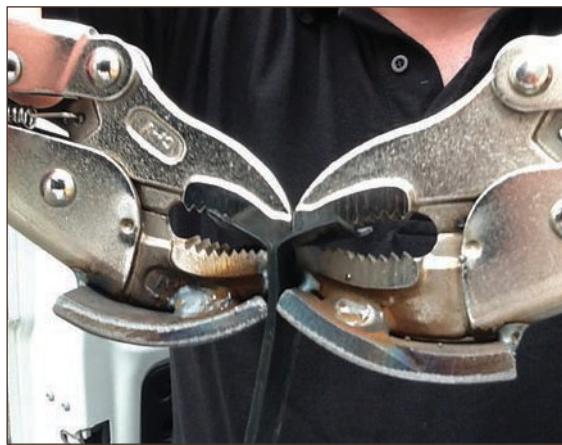
Figure A4.46 Testing a weld with 'dog bone' grips (courtesy MEC Environmental Ltd)

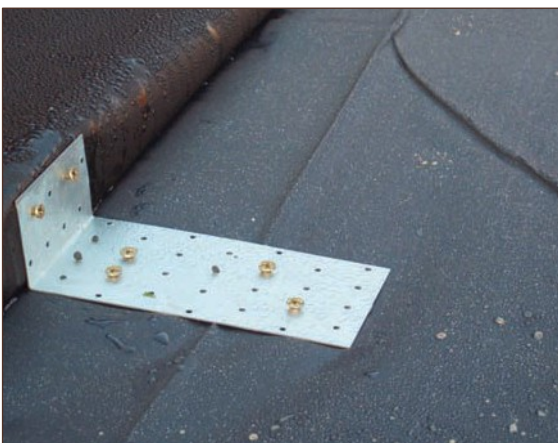
Figure A4.47 Follow-on works purposefully penetrating gas membrane (courtesy Card Geotechnics Limited)

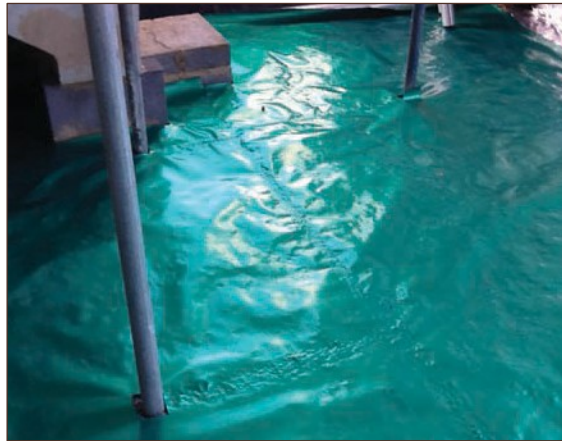
Figure A4.52 *Gas membrane cut by scaffolders and bricklayers after installation (courtesy MEC Environmental Ltd)*

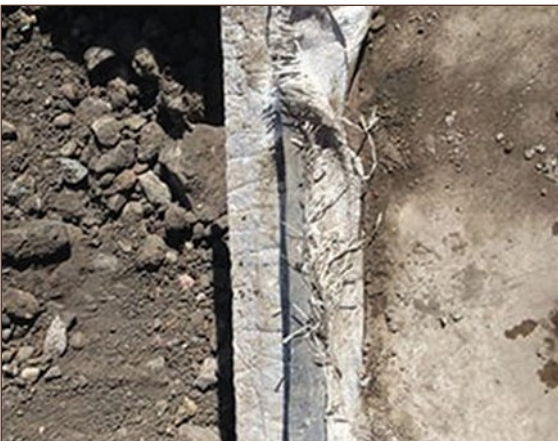
Figure A4.53 *Gas membrane left exposed for long period of time, shows significant fraying at cavity edge (courtesy NHBC)*

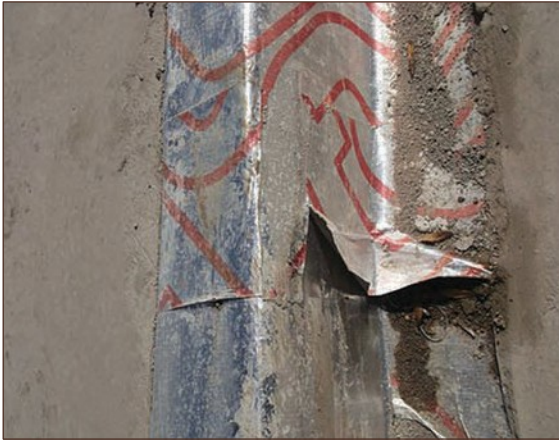
Figure A4.55 Gas membrane at stepped junction of slab to integral garage, appears to be susceptible to tearing when screed is poured. Screed may also weigh down on gas membrane if fitted too tight (courtesy NHBC)

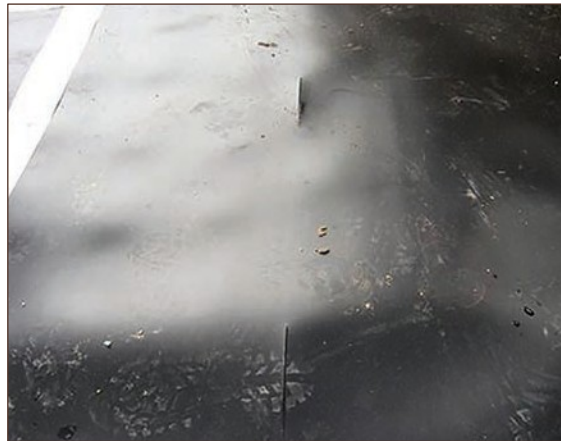
Figure A4.58 Damage caused to gas membrane by follow-on trade who cut/shaped the dry lining board directly on the unprotected installed gas membrane (courtesy NHBC)

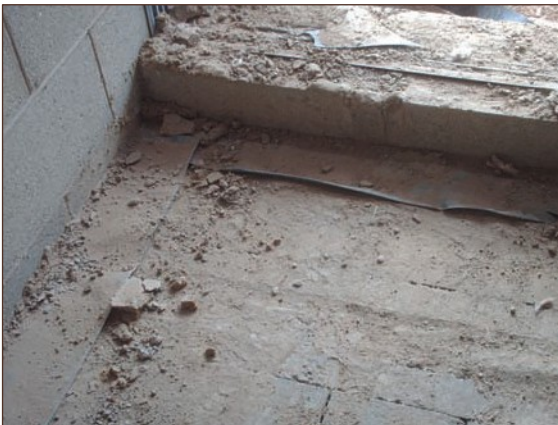
Figure A4.63 Absence of surface preparation prior to laying of gas membrane, debris likely to pierce gas membrane (courtesy Card Geotechnics Limited)

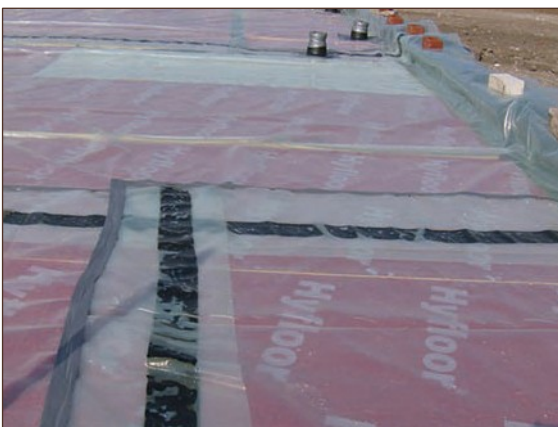
Figure A4.65 Wrinkling of gas membrane over joint has resulted in gaps (only visible due to the use of a transparent gas membrane) and the secondary seal uses ordinary gaffer tape rather than a proprietary product (courtesy Smith Grant)

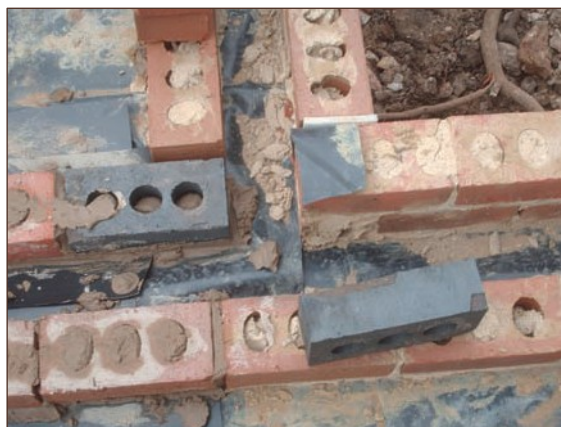
Figure A4.66 Follow-on trades proceeded work before gas membrane joints sealed (courtesy Card Geotechnics Limited)

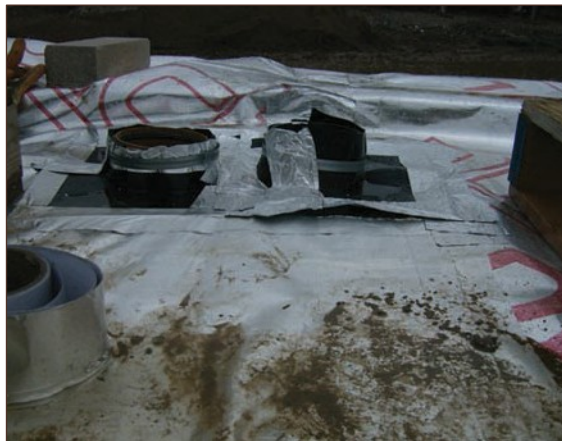
Figure A4.72 Joint between top hat and gas membrane has lifted due to poor fit and attempt to construct in very wet conditions (courtesy Smith Grant)

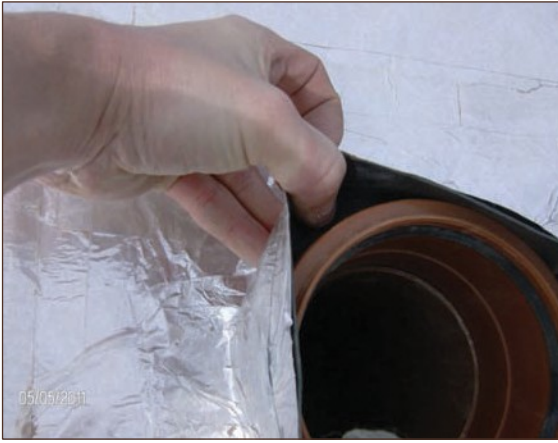
Figure A4.73 No bead of double sided butyl tape provided between interfaces of ID top hat and OD service pipe: cannot be compressed enough to form seal (courtesy Smith Grant)

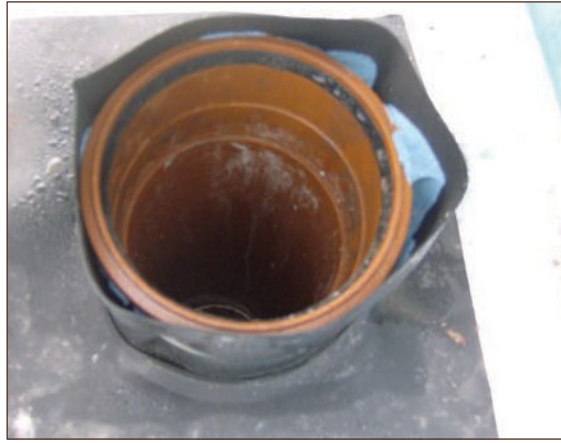
Figure A4.74 Gap between OD of service pipe and ID of top hat too large: cannot be compressed enough to form seal, even with the application of additional tape (courtesy Smith Grant)

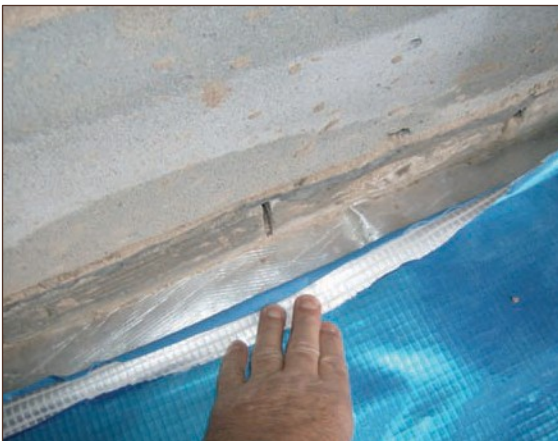
Figure A4.77 Small lap and no single sided tape used to achieve secondary seal (courtesy Smith Grant)

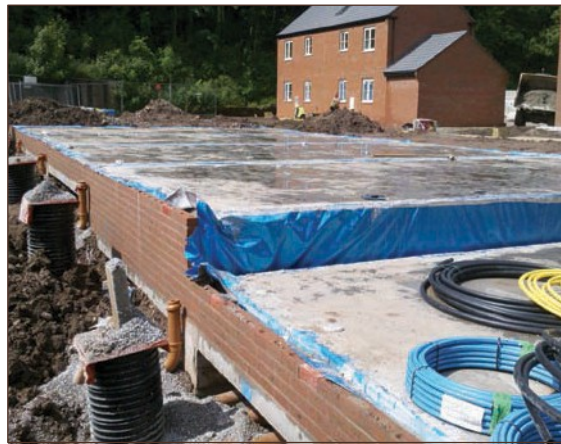
Figure A4.82 Gas membrane used to bridge cavity wall instead of DPC, leaving it exposed to damage by follow-on trades (courtesy Smith Grant)

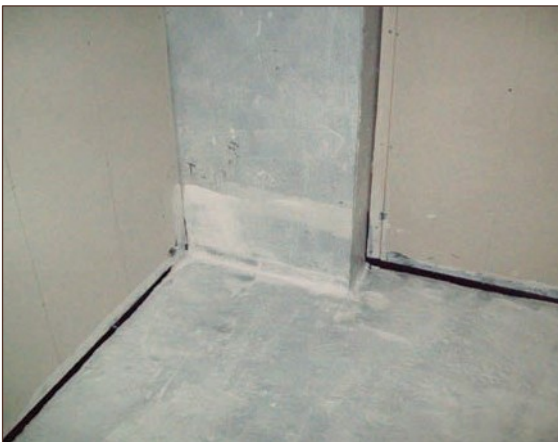
Figure A4.83 Poor quality installation of liquid gas membrane. Liquid gas membranes come in two colours (black and white) allowing coverage of each coat to be easily assessed. Here the gas membrane has been spread too thinly and inconsistently. In addition, it appears to have been applied to a damp surface, causing blistering (courtesy Card Geotechnics Limited)

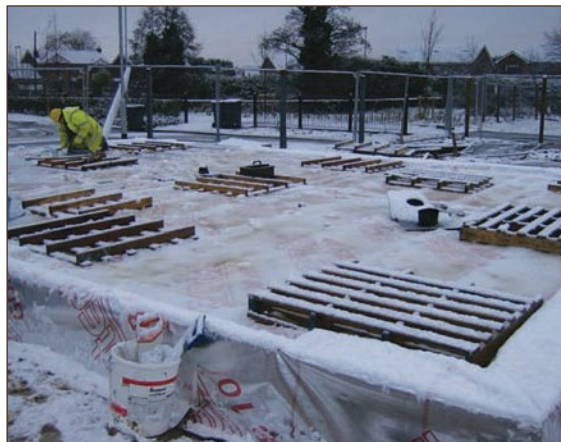
Figure A4.84 Taped joints are difficult to construct in adverse weather. Also difficult to inspect if covered with snow (courtesy Smith Grant)

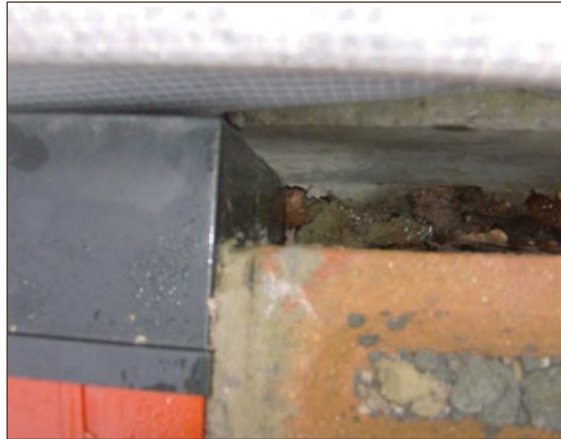
Figure A4.86 Cavity is becoming blocked with detritus. The vent holes in the beam are no longer visible (courtesy Smith Grant)
